IED Report

TITLE: (EXPLOSIVE HAZARD) IED EXPLOSION RPT (Directional IED) 2/B/2-325 AIR IVO (ROUTE MSR TAMPA): 1 CF KIA 2 CF WIA

(722D EOD / 2nd PLT / Team 2-1)

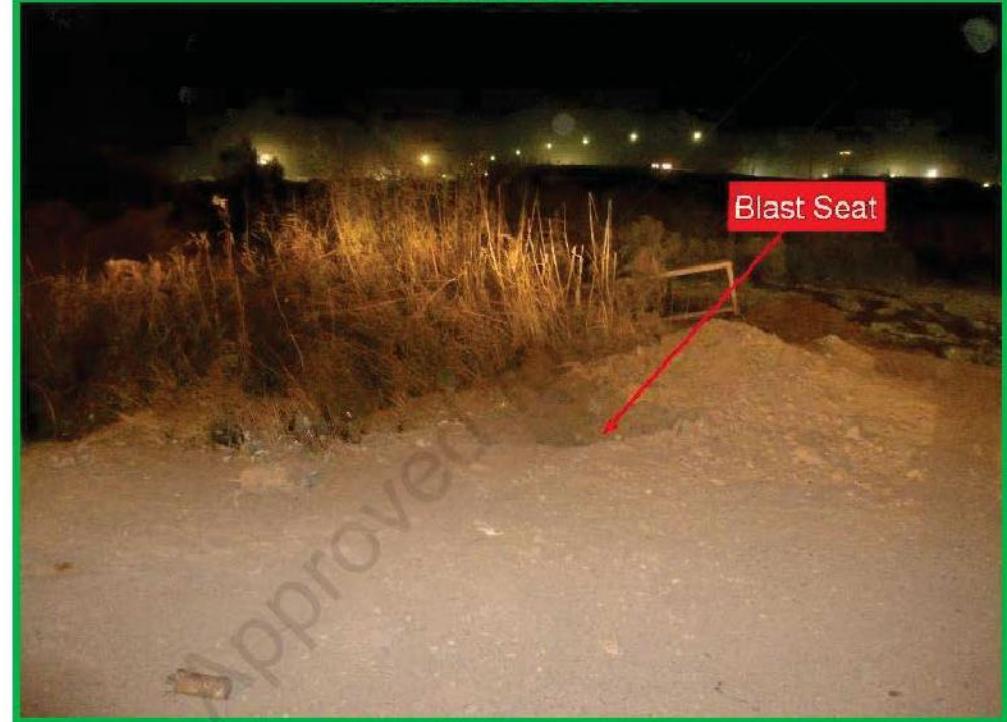
Blast Seat

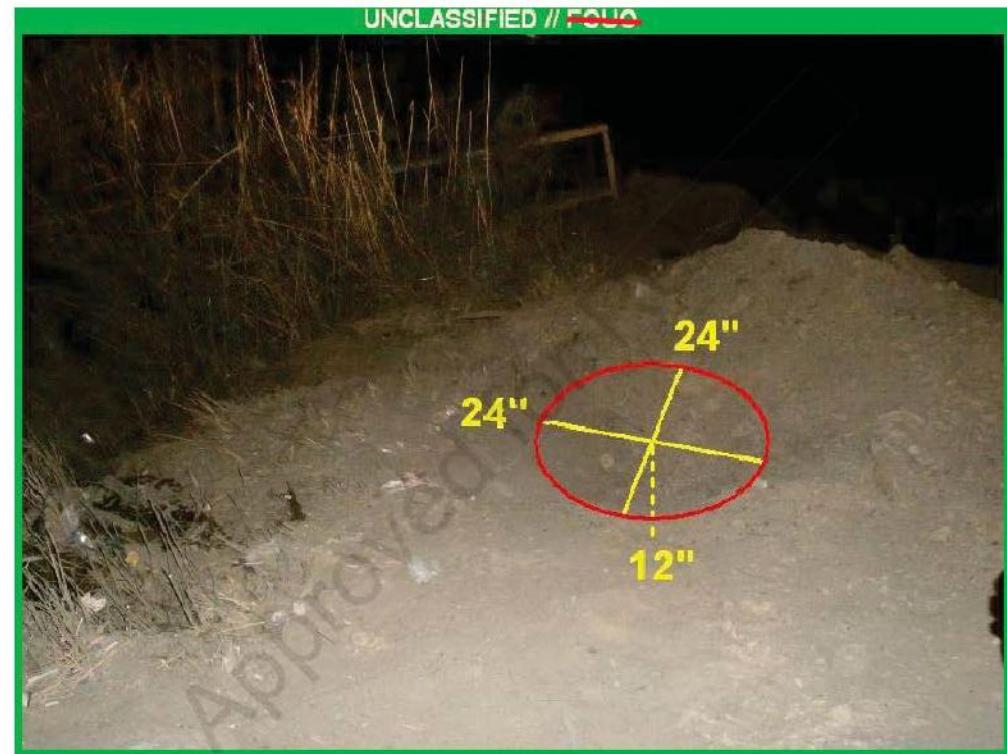
Blast Seat view from South

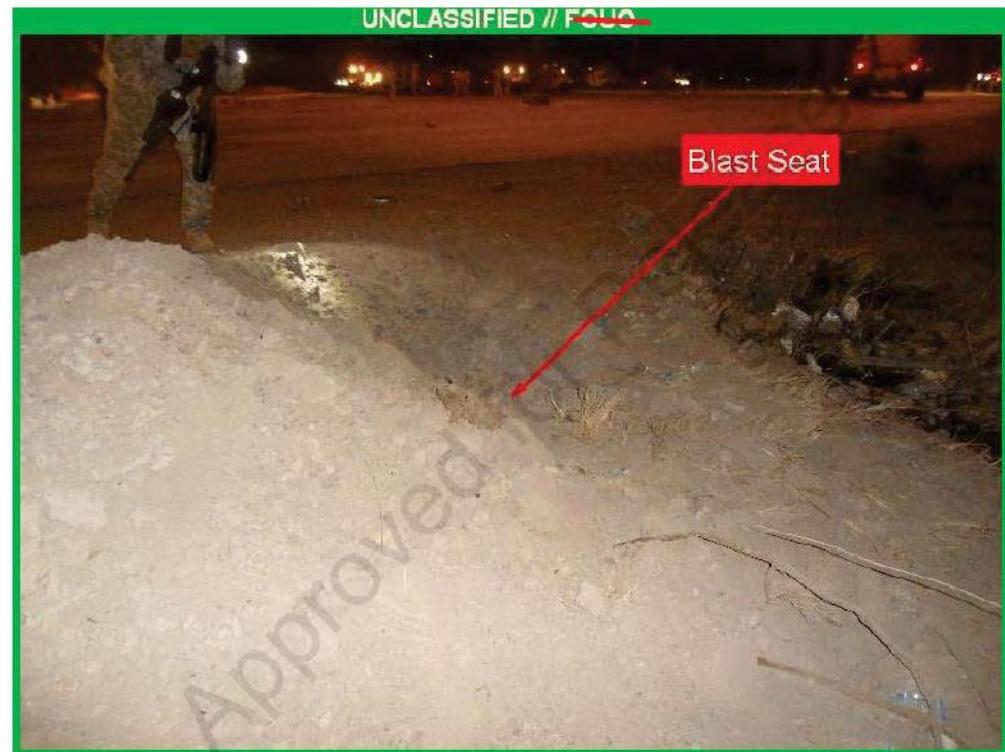
Blast Seat view from North West

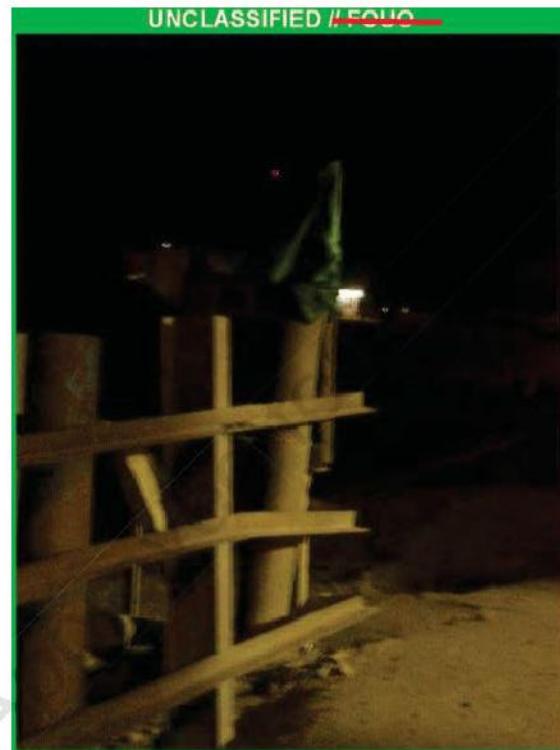
IT IS THE EOD TEAM LEADER'S ASSESSMENT THAT THE IED WAS AN EFP WITH AN UNKNOWN INITIATION SYSTEM. THE STRUCK VEHICLE WAS IMPACTED NEAR THE TOP OF THE PASSENGER SIDE INDICATING A HIGH ANGLE OF AIM, LIKELY TARGETING THE GUNNER. ALTHOUGH NO INITIATION SYSTEM WAS FOUND, THERE WAS A POLE MARKED WITH A GREEN TARP APPROXIMATELY 10M FROM THE BLAST SEAT THAT COULD HAVE BEEN USED AS AN AIMING MARKER.

Green Tarp on Pole

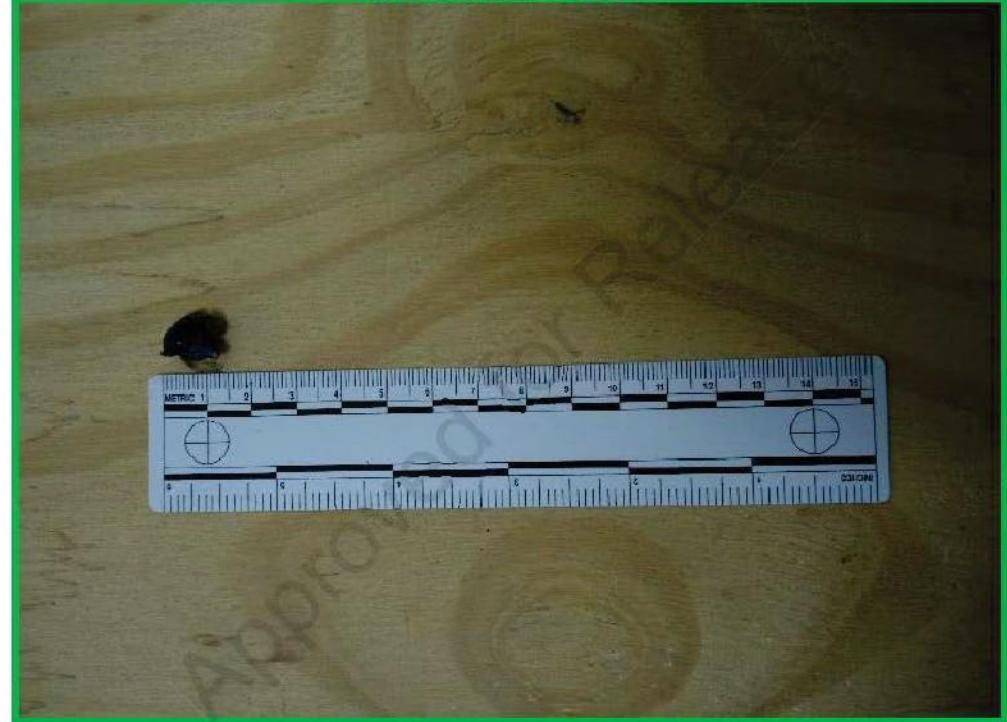
removed from inside vehicle

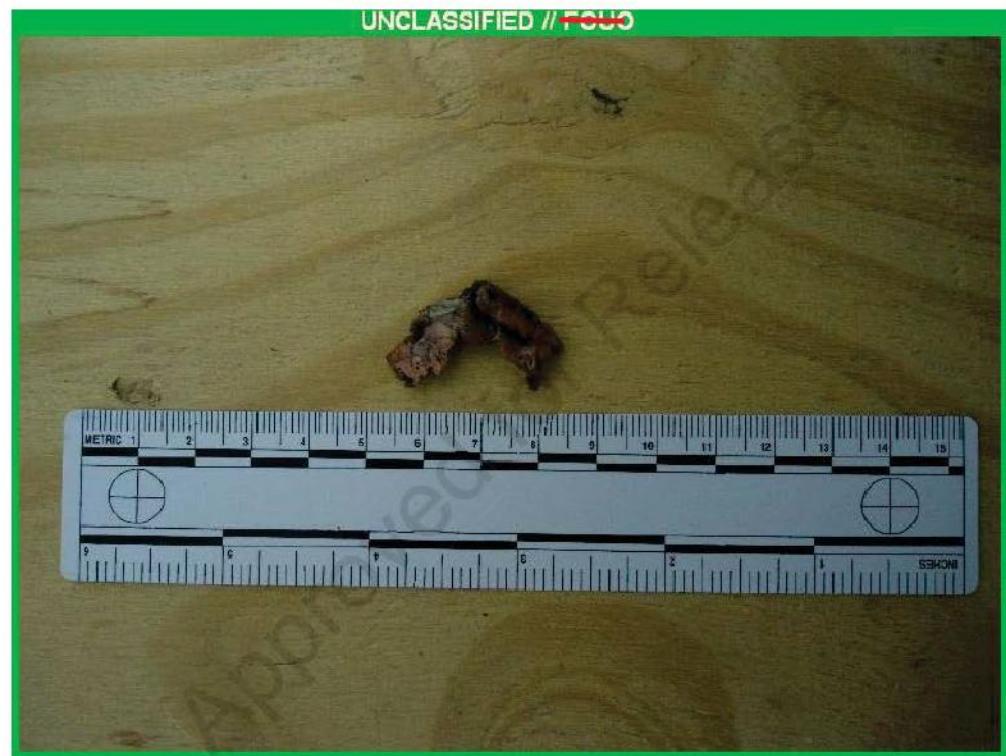
removed from inside vehicle
